*Early Domestic Architecture  
of Connecticut*

*By J. Frederick Kelly*

J. Frederick Kelly, A.I.A.

New Haven: Yale University Press

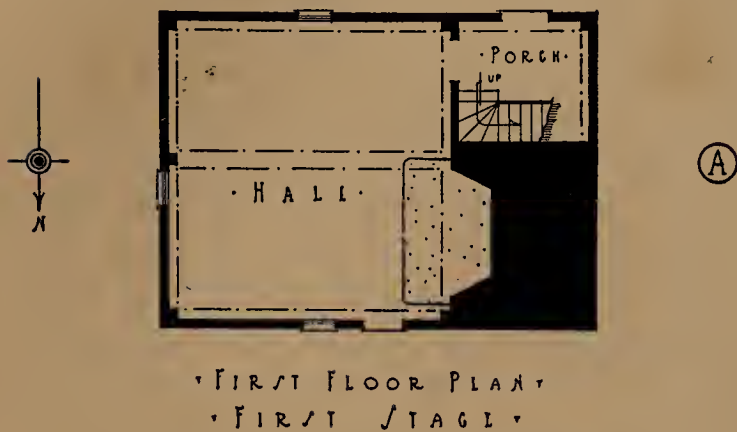
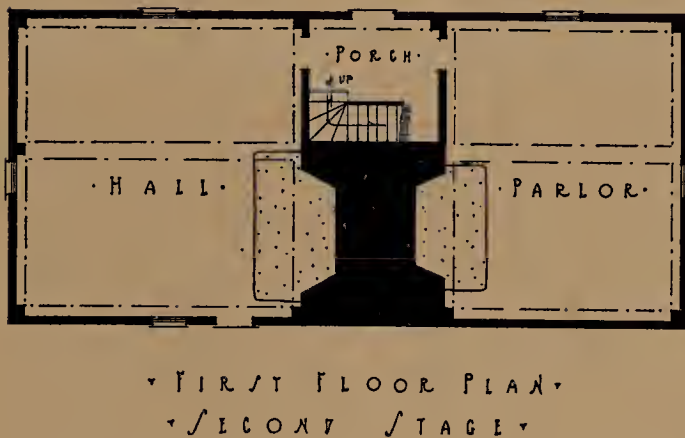
FIGURE I.

✓ THO'S. LEE HOUSE - LAST LYME ✓

The Thomas Lee house in East Lyme, which was begun in 1664, is, in its first stage, a perfect illustration of this type of plan. From A, Figure 1, it will be seen that the plan of this house was originally that of a single room, facing south, with a great stone chimney at the western end. It is probable that this chimney showed on the outside of the house for its entire height, as it does in the Norton house in Guilford to-day. (Plate I.) The stairs to the second floor were, at this stage, in the southwest corner, in front of the chimney stack. This plan of the Lee house in its first stage may be regarded as typical of the first or one-room period.

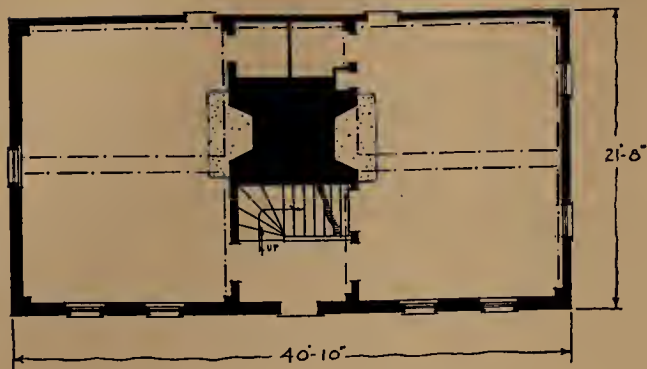
FIGURE 4.

▷ FIRST FLOOR PLAN  
 ↙ OLIVER WILLIAMS HOUSE - WETHERSFIELD ↘

The house of two-room plan—it soon became established as a type—forms the second stage in the development of the Connecticut house plan. The older Bushnell house near Saybrook (1678-1679) and the older Williams house in Wethersfield (circa 1680), Figures 3 and 4, furnish us with typical examples of the period. It will be seen that in each the chimney occupies its central position behind the stair porch. Once

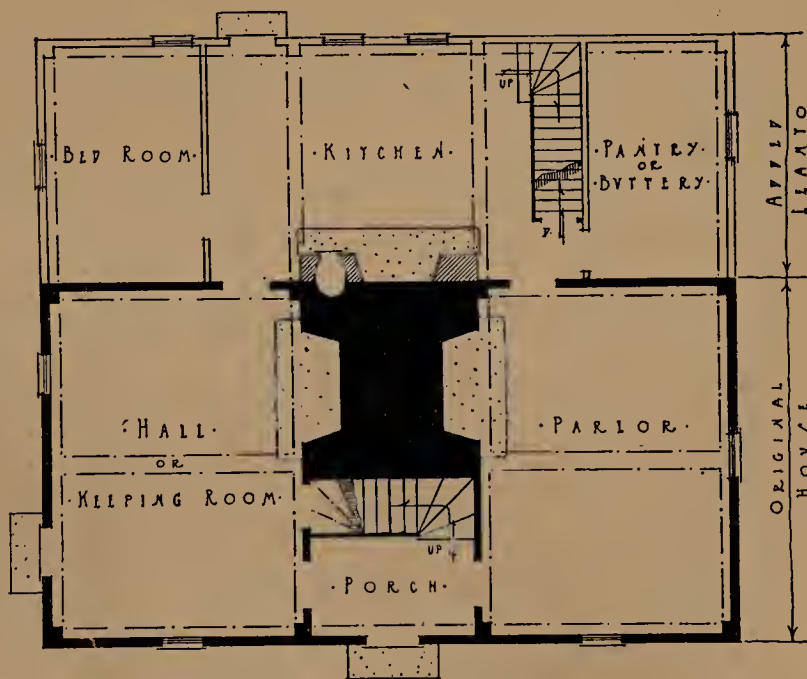
FIGURE 5.

▷ TYPICAL FIRST FLOOR PLAN  
 ↙ CENTRAL CHIMNEY TYPE ↘

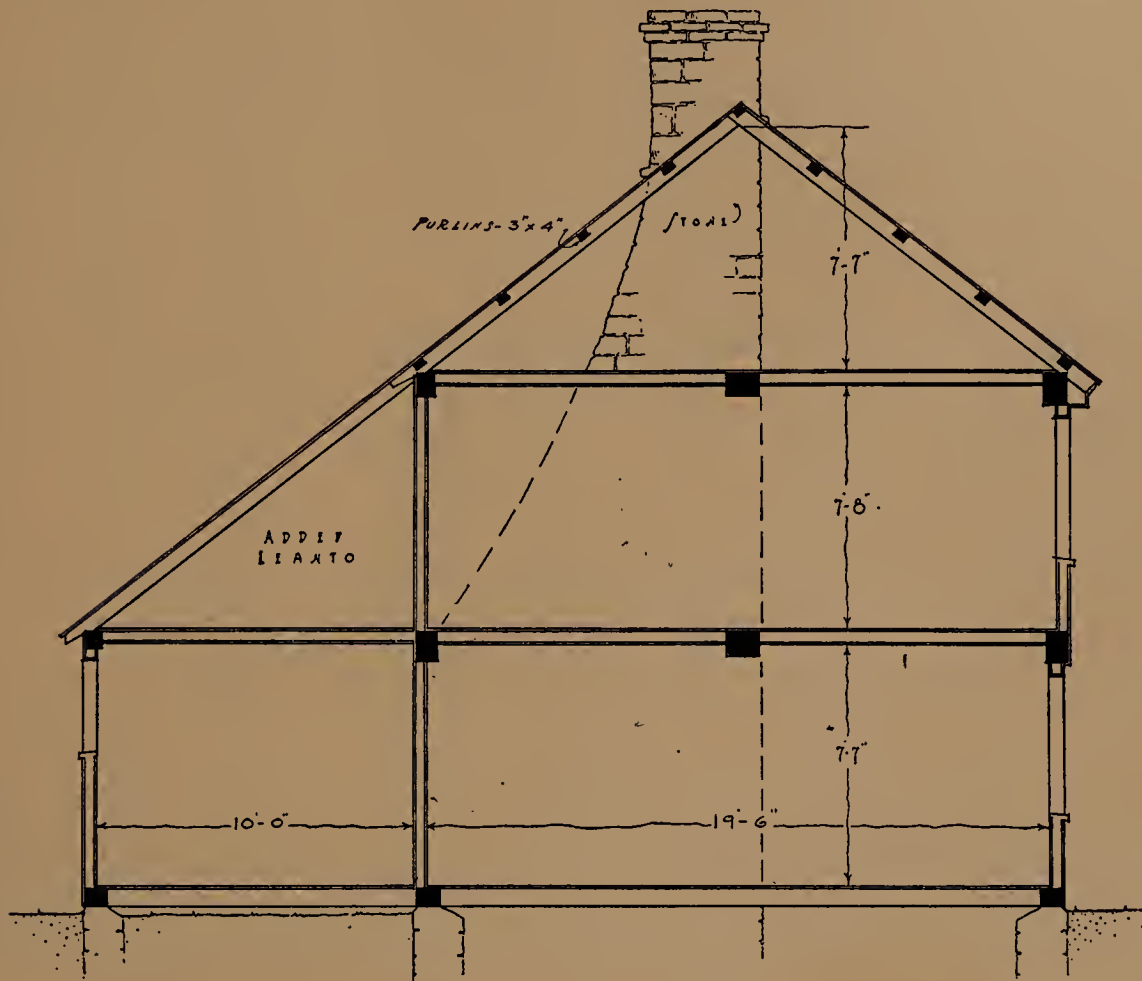
FIGURE 6.

• CROSS SECTION •

↙ HARRISON-LINSELY HOUSE - BRANFORD ↘

The ceiling joists of the lean-to ran from the old rear girts to the new rear lean-to plate. (Figure 6.) When the lean-to became an organic part of the house, this framing became integral with that of the main body of the house. In this event the old rear girt becomes in reality a second summer, though, unlike the first one, it does not appear across the ceiling of a room.

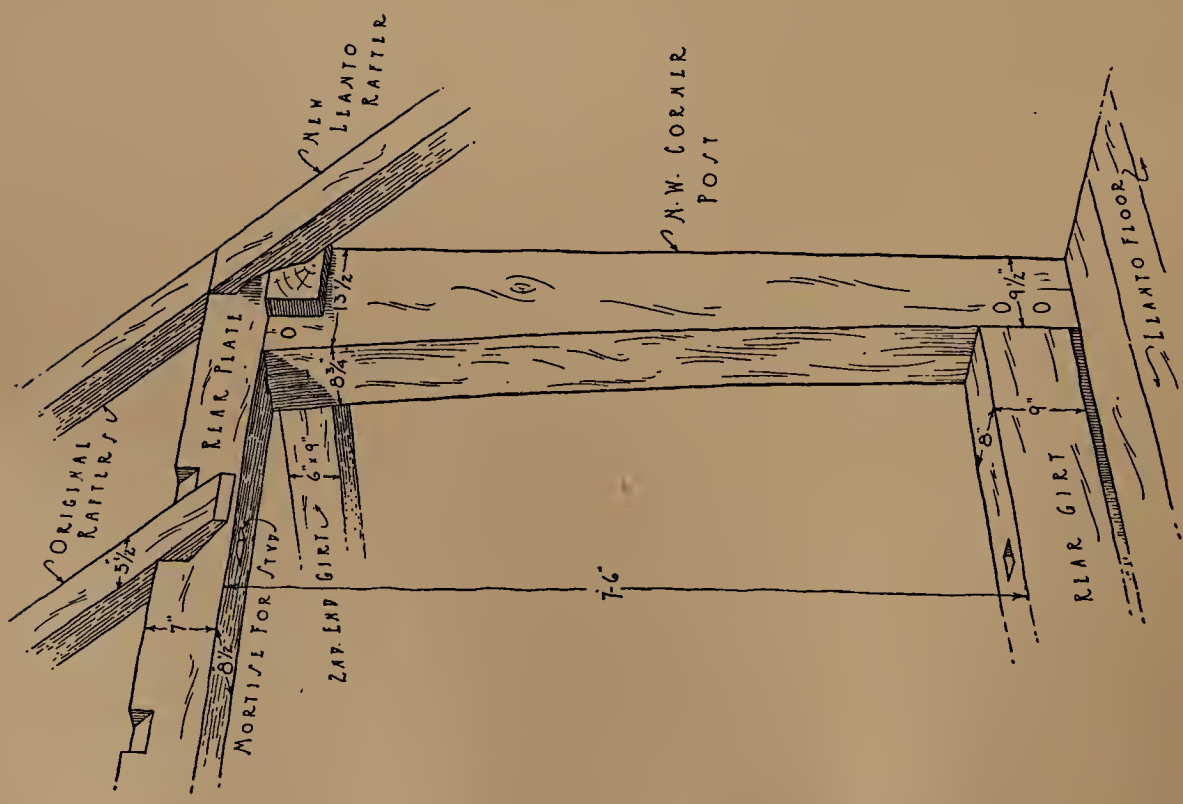
FIGURE 7.

STYLER HOVSL - BRANFORDS

plate of the house. (Figure 7.) The pitch of the lean-to roof was generally the same as that of the old roof above it. When, as in many instances, there is a slight variation in the roof angle, the discrepancy is a clear indication of subsequently added work. (Figure 8.) The lean-to evidently came into use very early in the days of the colony, for the New Haven Court Records for 1649 mention the "leantoe of Robert Parson's house."

Houses of the added lean-to type are of very common occurrence; in fact, this is one of the most typical forms of the early Connecticut house. The Tyler house, near Branford (*circa* 1710), the Acadian house in Guilford (1670), and the Harrison-Linsley house in Branford (1690) all have lean-to additions. (Figures 6 and 8.) Originally each was of the two-room type of plan. An inspection of the lean-to attic in houses of this type generally furnishes the investigator with sufficient architectural evidence to decide conclusively whether or not the lean-to is a later addition or an integral

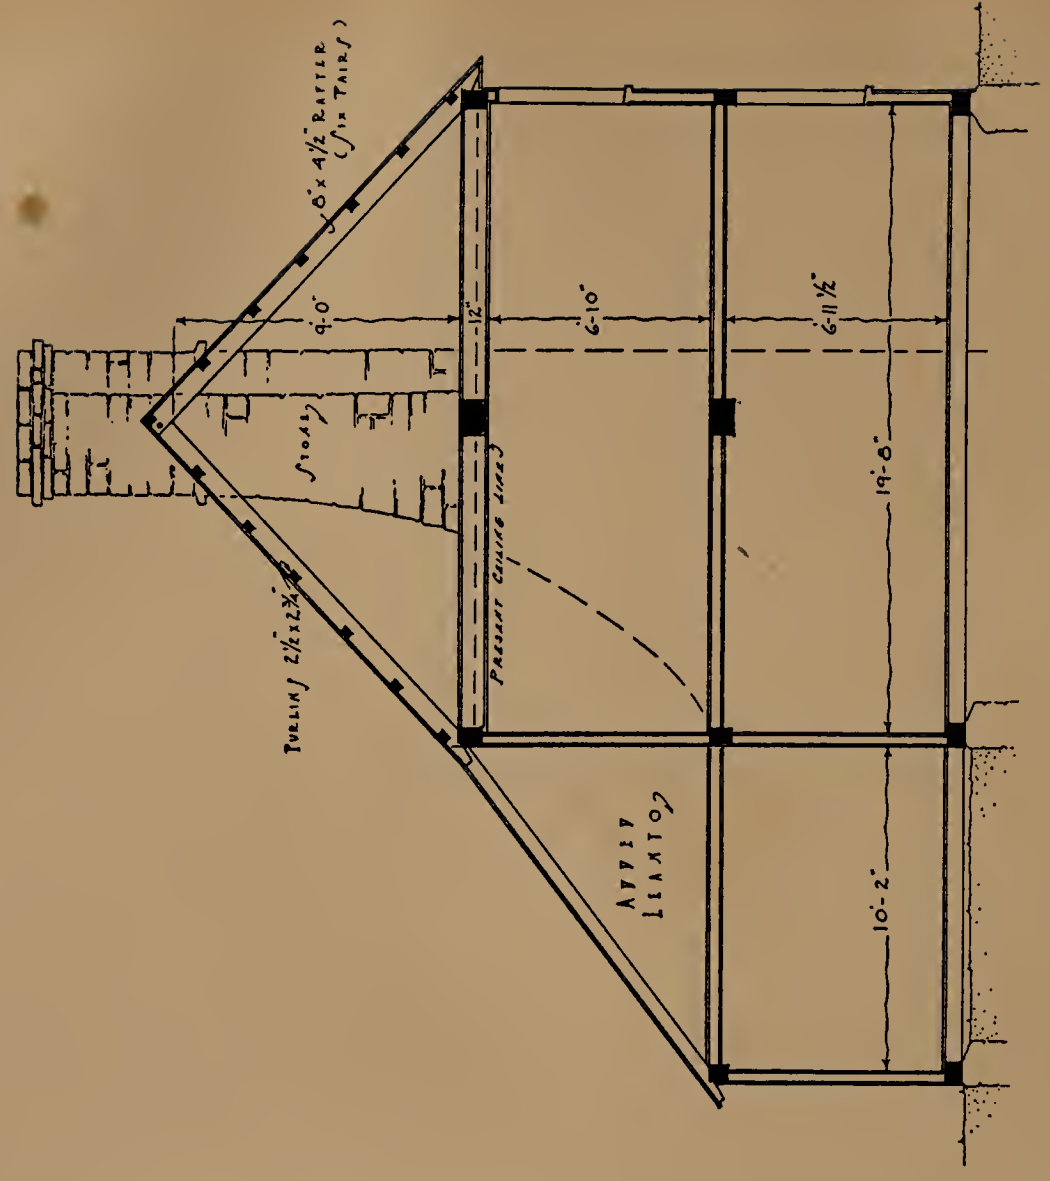
FIGURE 8.

ACAVIAN HOVSL - GUILFORDS

part of the house itself. The existence of a separate set of roof rafters extending from the rear plate of the main house down to the rear plate of the lean-to does not always necessarily indicate that the rear part is of later date; nor does a difference in level between the floors of the front rooms and of the lean-to attic. The existence of clapboards, however, on the outside of the rear walls of the front rooms, beneath the lean-to roof, is incontrovertible proof that the rear portion of the house is a built-on addition. Old weathered clapboards are still in place on parts of the original rear walls of all three of the just-mentioned houses. In each they are of oak, riven out, and applied directly to the studs. Those in the lean-to attic of the Acadian house still bear traces of the original red paint with which they were covered.

The roof of the Acadian house in Guilford (1670) is framed in quite the same manner, with the exception that there are six rows of purlins, front and rear, in addition to that at the ridge. The principal rafters are  $4\frac{1}{2}$  by 8 inches in section, and the purlins  $2\frac{1}{2}$  by  $2\frac{3}{4}$  inches, framed flatwise into the rafters. (Figure 8.)

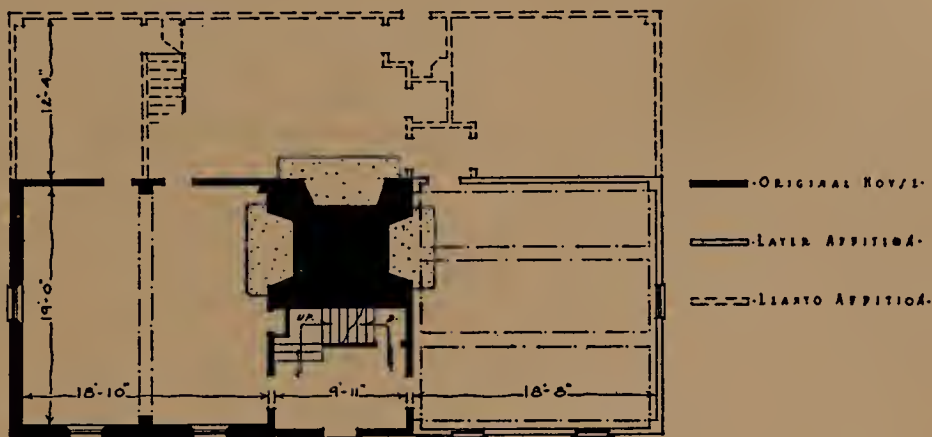
FIGURE 9.

HEMPSTEAD HOUSE - NEW LONDON

Both the Hempstead house in New London (1643) and the Lee house, which has been discussed, have lean-to additions. From the first-floor plan of the Hempstead house, which is shown in Figure 9, it will be seen that it was, like the Lee house, originally of one-room plan. Later on another room was added on the opposite side of the chimney, which thus became enclosed; and finally a lean-to was built across the entire rear of the house. Therefore this house, as it exists to-day, embodies three different stages in the growth of the house plan. The first-floor plan of the Lee house, as it now stands, is shown in Figure 10. After its plan had arrived at the two-room stage, as shown by B, Figure 1, the house underwent a great change. Up to that time it had faced the south; but, owing to the construction of a new road about a hundred feet to the north, what had formerly been the rear became the front, and a lean-to was built across the south side. This modification of course necessitated a reconstruction of the chimney in the space formerly devoted to the stairs; whereupon the resulting arrangement became what it is to-day. The lean-to of this house, it will be noted, is built across what was originally the front.

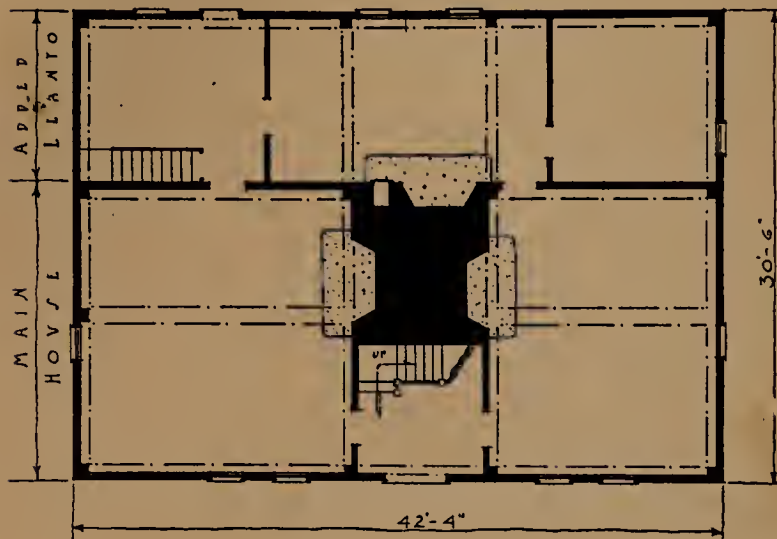
FIGURE 10.

THOMAS LEE HOUSE - EAST LYME  
 "FIRST FLOOR PLAN"  
 "FINAL STAGE"

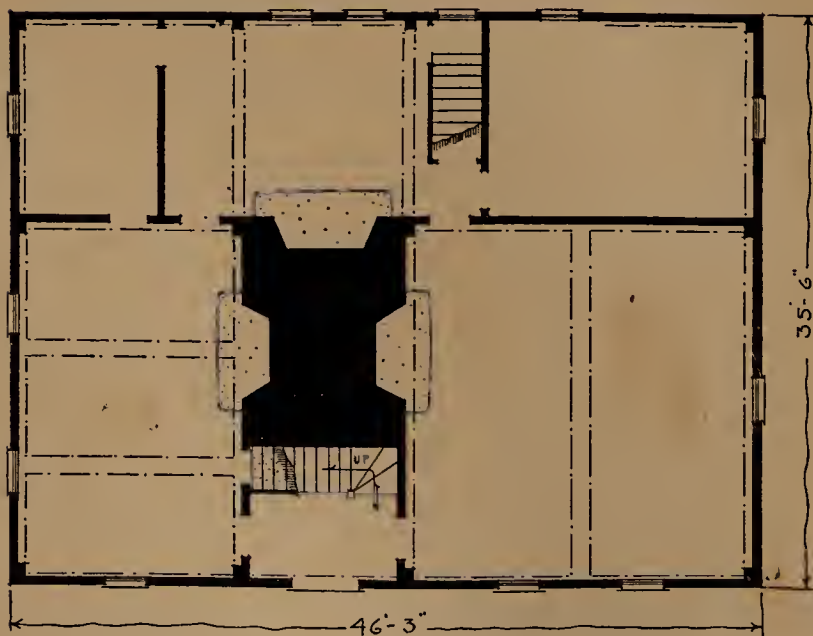
FIGURE 11.

GRAVES HOUSE - MADISON

The Graves house in Madison (1675), which is also of the added lean-to type, displays in its first-floor plan (Figure 11) an unusual lack of symmetry, although the layout is typical. Generally the variation in size between the two front rooms is very small, if it

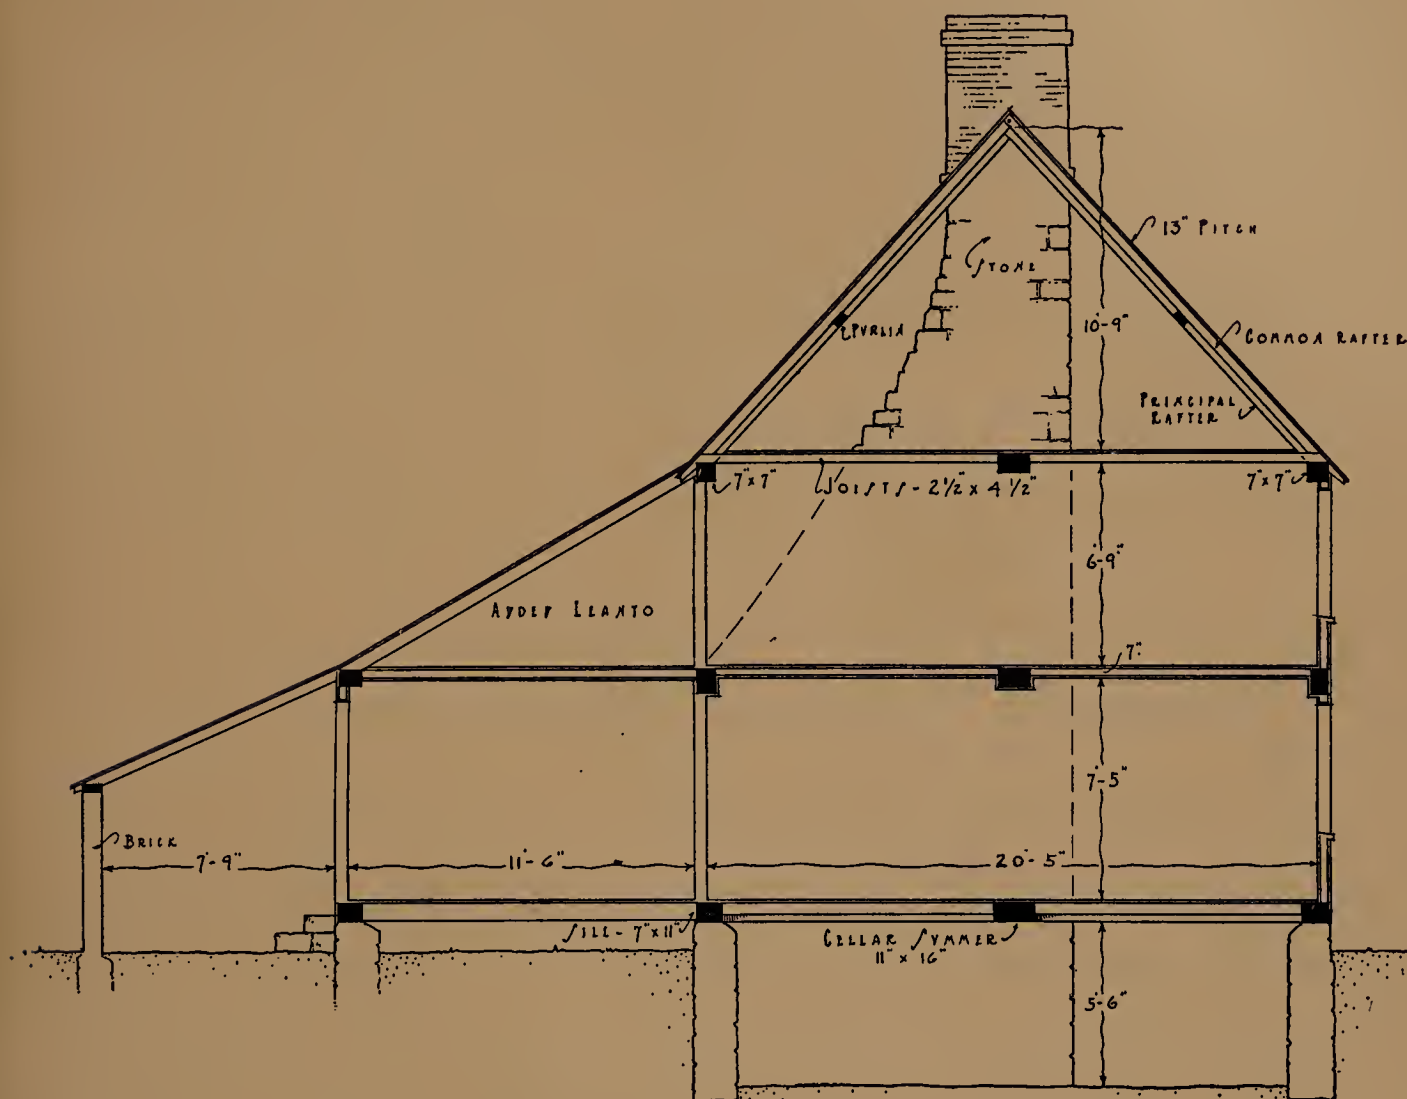
FIGURE 12.

• CROSS SECTION •  
 / BIDWELL-MIX HOUSE - WEST HARTFORD /

of the long lean-to roof, with its fine lines sweeping from the ridge nearly to the ground. (Figure 12.) However, the utilitarian advantage of the change was great: the formerly useless attic-like space of the lean-to on the second floor gave way to three additional rooms of full head-room.

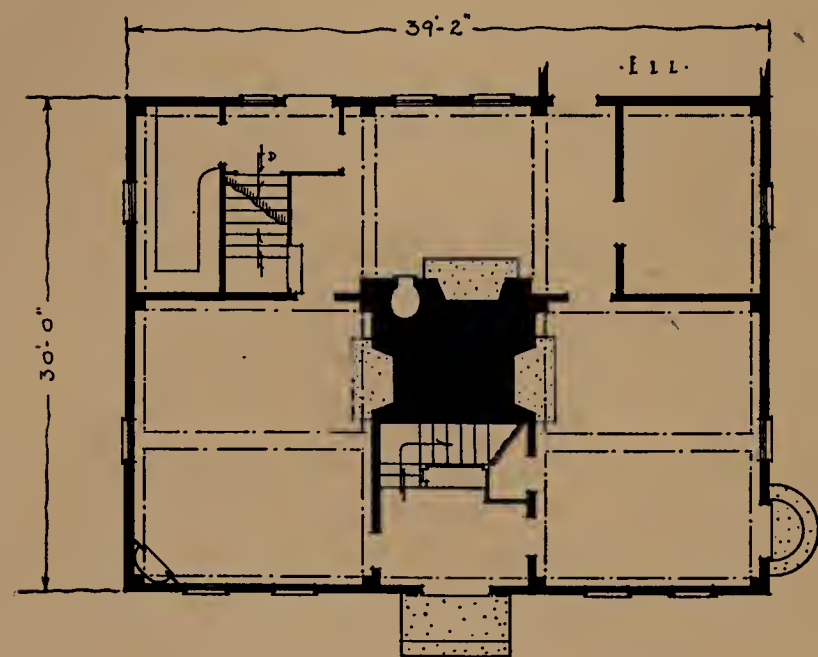
FIGURE 13.

▼ FIRST FLOOR PLAN ▼  
 ↙ WARHAM WILLIAMS HOUSE - NORTHBURY ↘

The first-floor plan of the Warham Williams house in Northford (1750), shown in Figure 13, is a typical illustration of the layout of this period. The plan of the second floor repeats that of the first, so that the house is one of ten rooms. On the first floor we

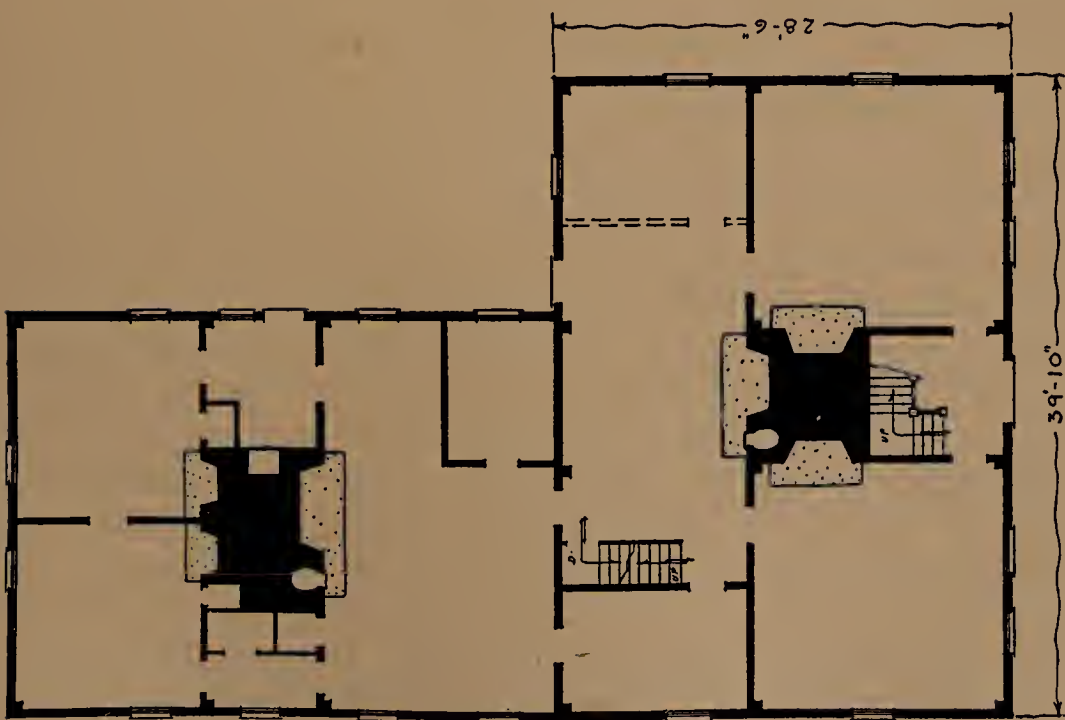
FIGURE 14.

✓ FIRST FLOOR PLAN ✓  
 ✓ REV. DR. HUNTINGTON HOUSE - 19. COVENTRY ✓

As may be seen from the accompanying plans, the chimney had hitherto been the central feature, and, from its central position behind the stair porch, had not only dominated, but actually governed the plan. In the plan arrangement there now began a change which must be regarded as of extreme significance. This was the introduction of the central hallway, extending from the front to the rear of the house, with an outside door at either end, and the consequent division of the chimney into two parts. A typical layout of the period is shown in Figure 16. It will be seen that the new arrangement really consisted

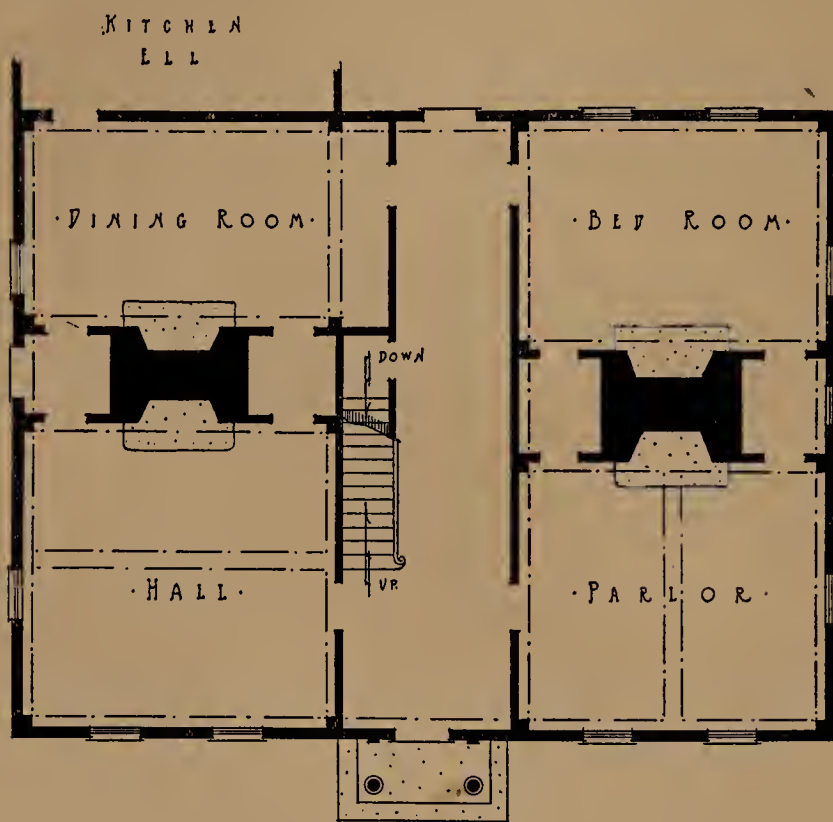
FIGURE 16.

• TYPICAL FIRST FLOOR PLAN •  
 / CENTRAL HALL TYPE /

One important point should be noted in connection with the central-hall house plan: namely, that the first-floor scheme still continues to be the dominating one, determining the arrangement of the floor above it, as is always the fact with the central-chimney house. This dominance of the first floor is probably due in large measure to the fact that the partitions, which were thin and non-bearing, were mainly governed in their positions by the girts or other major units of construction with which they coincided.

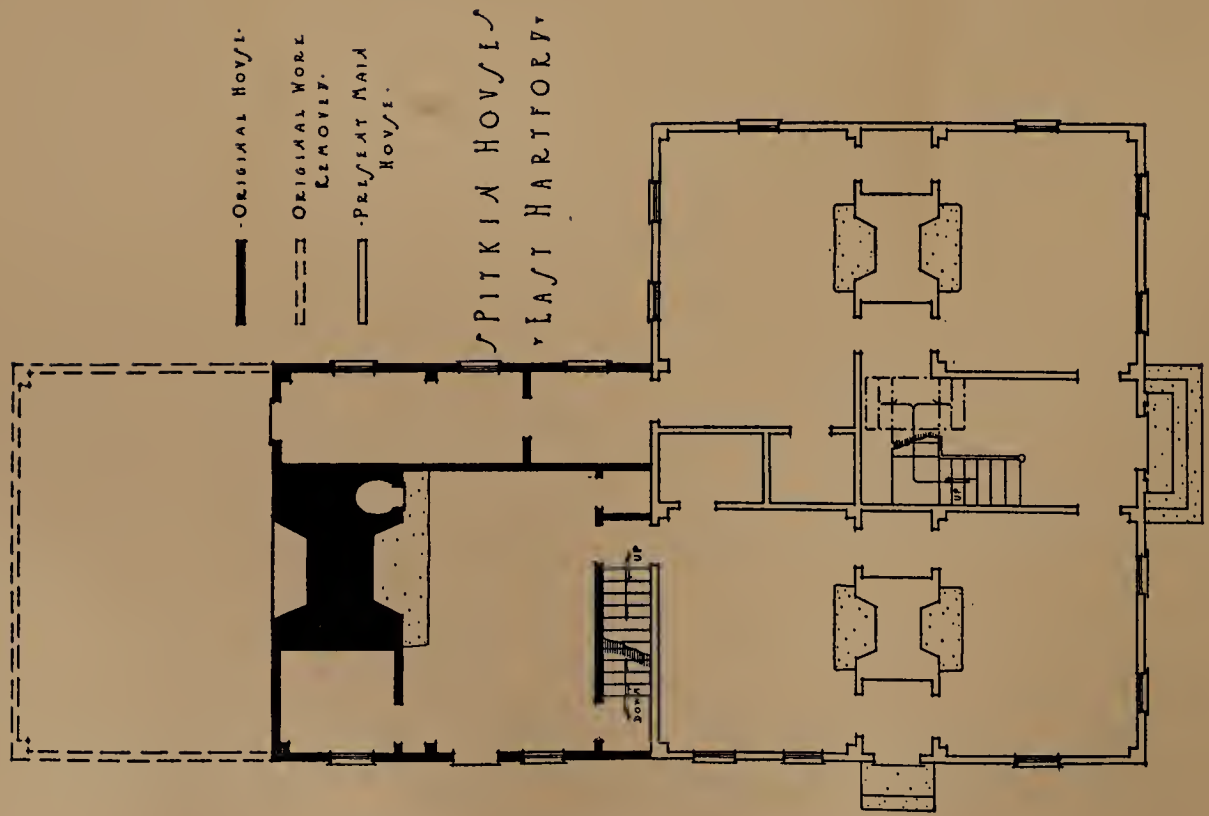
FIGURE 18.

FIRST FLOOR PLAN

- PROBABLE ORIGINAL HOUSE.  
 - " " LATER ADDITIONS.

in East Hartford (1740-1750) is an example. (Figure 18.) In some instances such rear ells were later additions, built to accommodate the kitchen and its dependencies, in order that the original kitchen of the house proper might be used as a dining room. It appears, though, both from old family records and from much purely architectural evidence, that the rear ell is very often the older structure, in some cases moved to its position behind the main house, in others standing upon its original foundations and occupied as a dwelling during the construction of the main house. The rear ell of the Webb-Welles house in Wethersfield (1751), for instance, is of considerably earlier date than the main house itself.

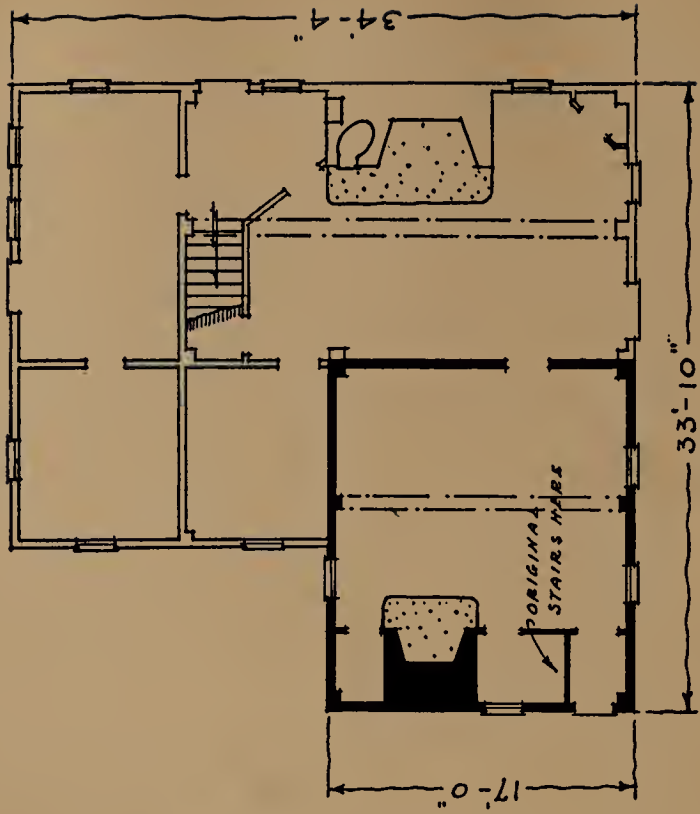
FIGURE 19.

FIRST FLOOR PLAN

RAYMOND HOUSE - ROWAYTON

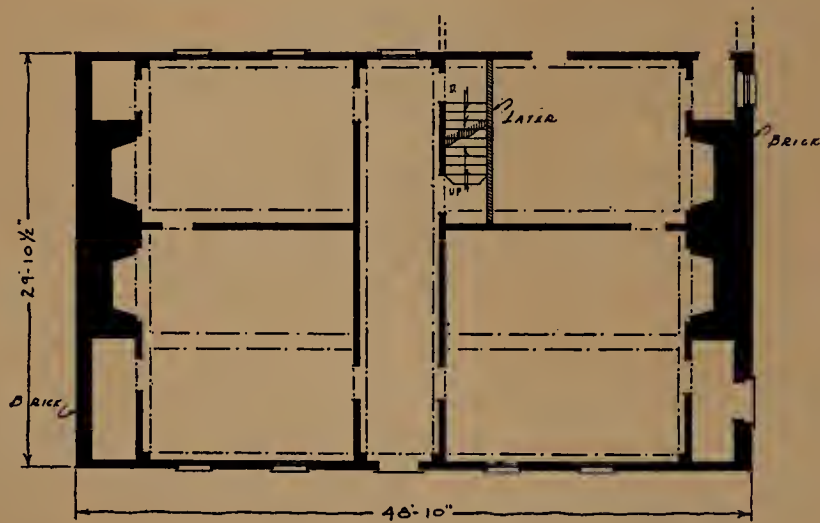
FIGURE 21.

• FIRST FLOOR PLAN •

✓ SHELDON WOODBRIDGE HOUSE - HARTFORD ✓

Sheldon Woodbridge house, built 1715, which once stood on Governor Street in Hartford, is shown in Figure 21. The plan arrangement is similar to that of the Morris house, but the masonry ends were constructed of brick. The Timothy Strong house (*circa* 1753), which once stood in Windsor, and which is illustrated in Plate IV, was also a house of this type. The small story-and-a-half house shown in Plate IV, which stands on the Boston Post Road near Madison, also falls under this classification of masonry-ended frame houses. As in the three foregoing examples, the fireplaces are built into the end walls.

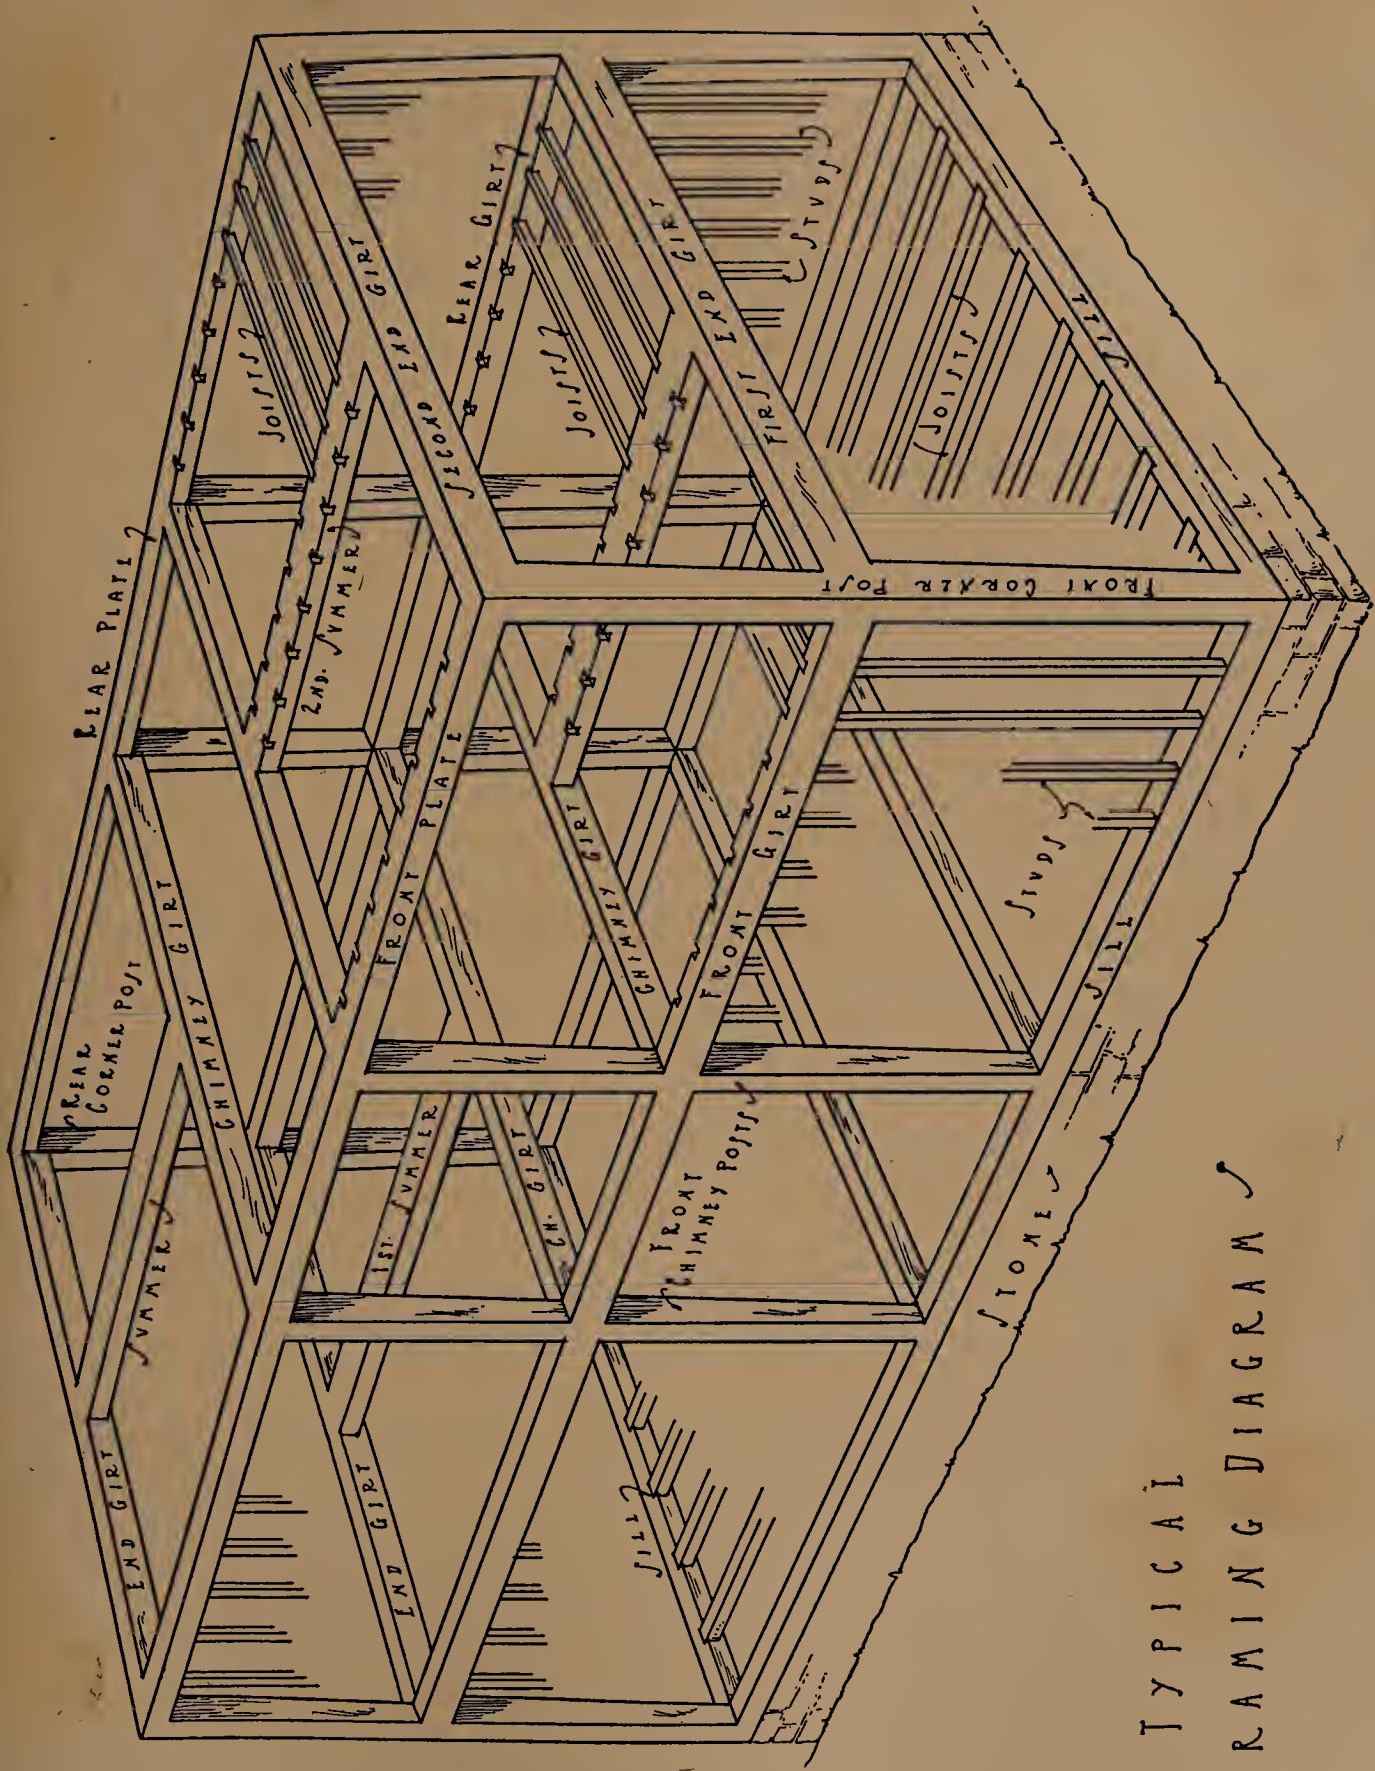
FIGURE 23.

✓ TYPICAL  
FRAMING DIAGRAM ✓

A typical framing system of a two-room-plan house is illustrated in Figure 23. From this drawing it will be seen that the general scheme of construction was as follows: upon the foundation walls of stone or brick, a continuous horizontal timber, variously known as the sill, "cill," or "grundsell," was laid. The last term may be seen in the General Court Records for New Haven, of December 2, 1656, which read as follows: "The Governor acquainted the Towne that the occasion of this meeting is aboute the meeting house, *wch* hath been viewed by workmen and finde it verey defective, many of the timbers being very rotten, besides the *groundsell*s." Usually about eight or nine inches in its sectional measurements, the sill was bedded upon its broader side, or, in other

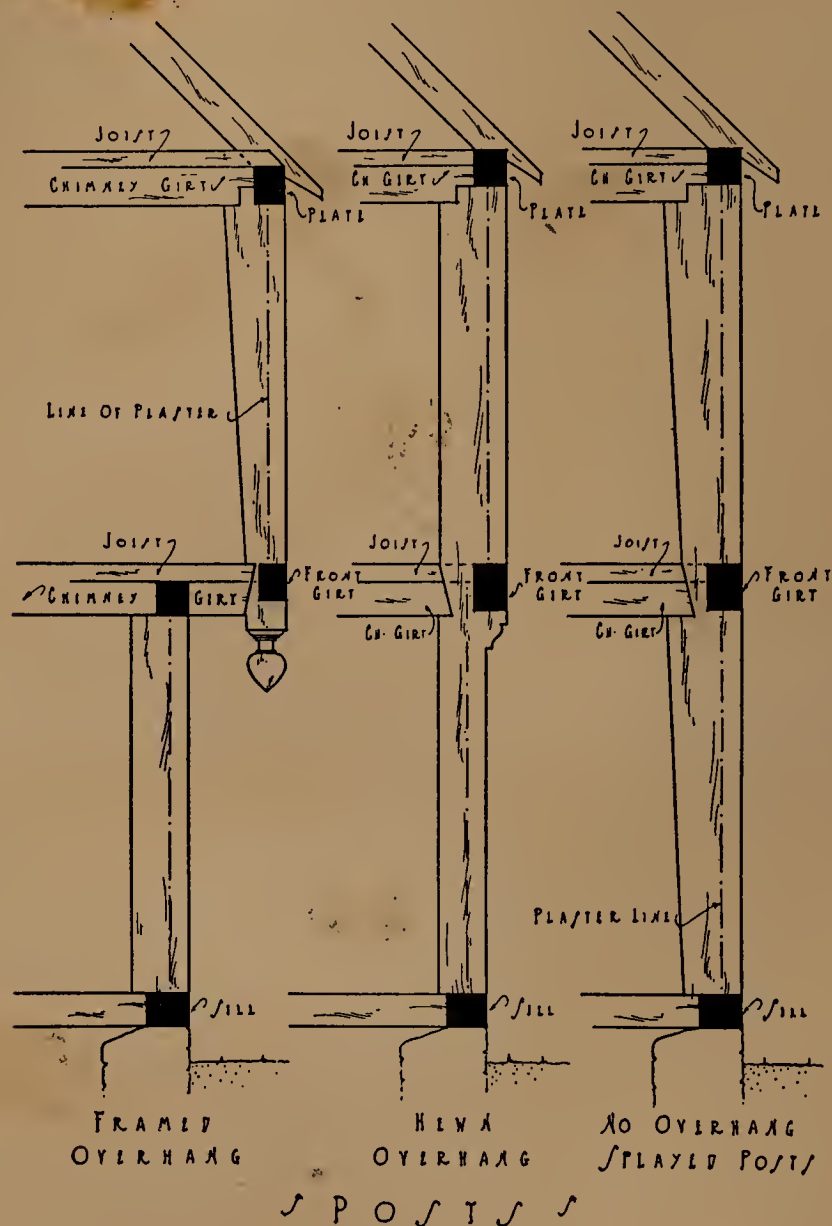
FIGURE 27.

wooden peg driven through it. Where there was no framed overhang of the second story, the posts were of one piece from sill to plate—in other words, through the height of two stories. (Figure 27.) Four similar posts, making a total of eight in all, were also erected—two in the front and two in the rear wall—as intermediate supports. These four posts

From Figure 27 a clear idea may be gained of the manner in which the framed overhang was constructed. It will be seen that the posts were but a single story in height, and that the second-story posts were framed out upon the projecting ends of chimney and end girts. Into these second-story posts a second front girt was framed. The system of double first-story front girts is therefore typical of the framed overhang. The projection of the second story beyond the first was generally in the neighborhood of two feet, which it never exceeded, though in some cases it was less. It should be noted that the framed overhang did not occur in towns lying outside the Connecticut River Valley, and that it never existed in the New Haven Colony.

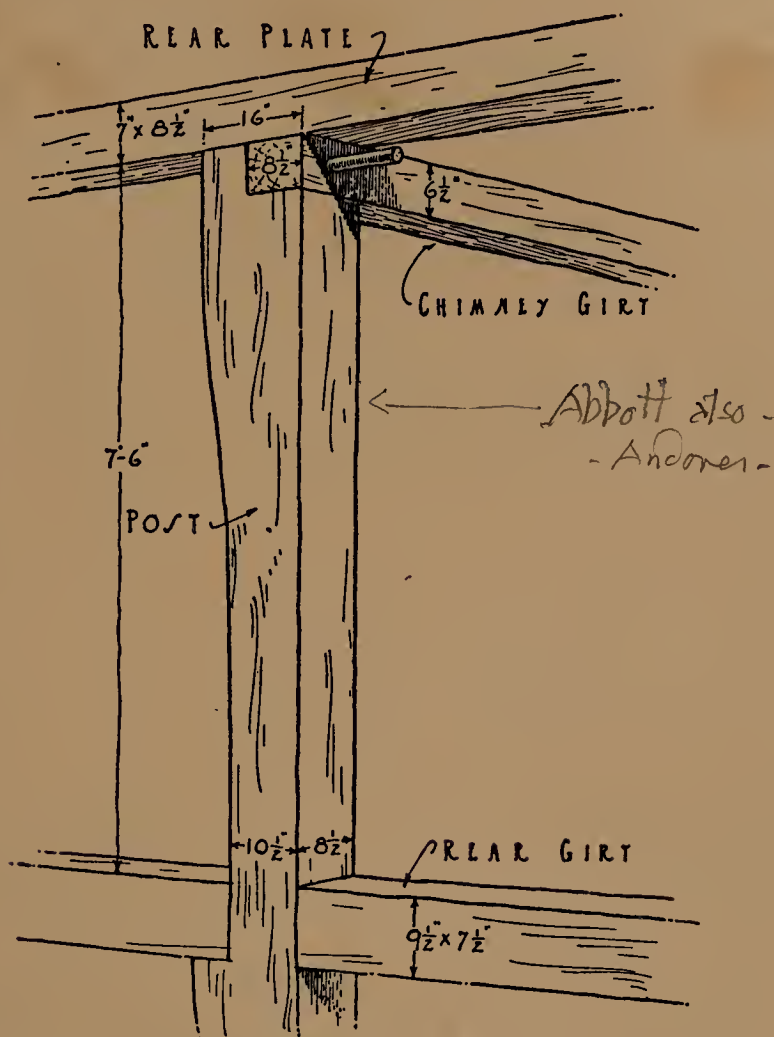
FIGURE 28.

are known as the front and rear chimney posts, according to their position. In the earliest houses, all eight posts “flare” or increase in size in one transverse dimension from floor to ceiling. Accordingly there was a double flare in the total height of each post—one flare for each story. Most often this flare is parallel with the chimney girts, though it occasionally occurs in the other direction—*i.e.*, so as to be parallel with the ridge of the roof. A post turned in the latter direction is shown in Figure 28.

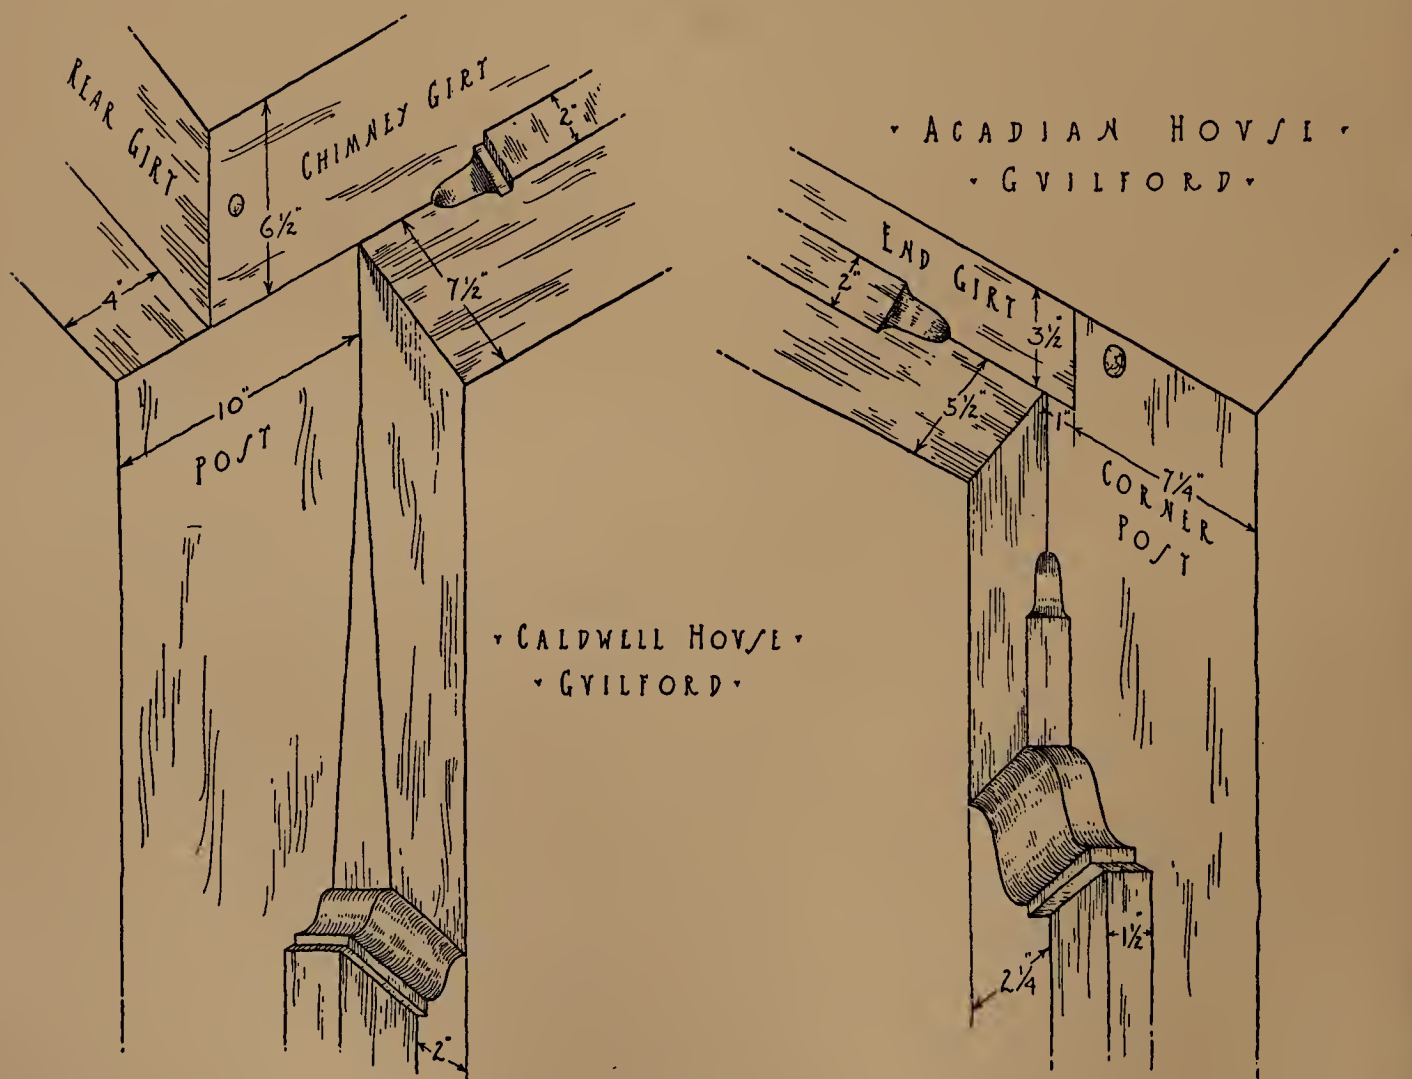
FIGURE 33.

There are two reasons for the existence of the flare. In the first place, it was a survival of framing tradition; for it is to be found in the half-timber work of England. Secondly, it was done to provide a better seat or bearing for the ends of the horizontal girts which it was the duty of the posts to carry, and which were framed into them. (Figures 29 and 30.) In some regions, principally the shore towns between New Haven and Saybrook, the added depth at the tops of the posts which provided a support for the ends of the girts was secured in other ways than by simply flaring one side of the post. The older Bushnell house in the town of Saybrook (1678-1679) displays posts of shouldered form (Figure 26), a rare device. The corner posts of the Harrison-Linsley house in Branford (1690) project into the rooms, and are splayed only in the upper third of their height. (Figure 31.) Two other schemes are illustrated in Figure 32, that which was used in the Starr house (*circa* 1645) being typical of the whole Guilford school, which was more elaborate than similar work elsewhere. In that region the increase in depth of the posts was very often given a quaintly ornamental treatment. (Figure 33.)

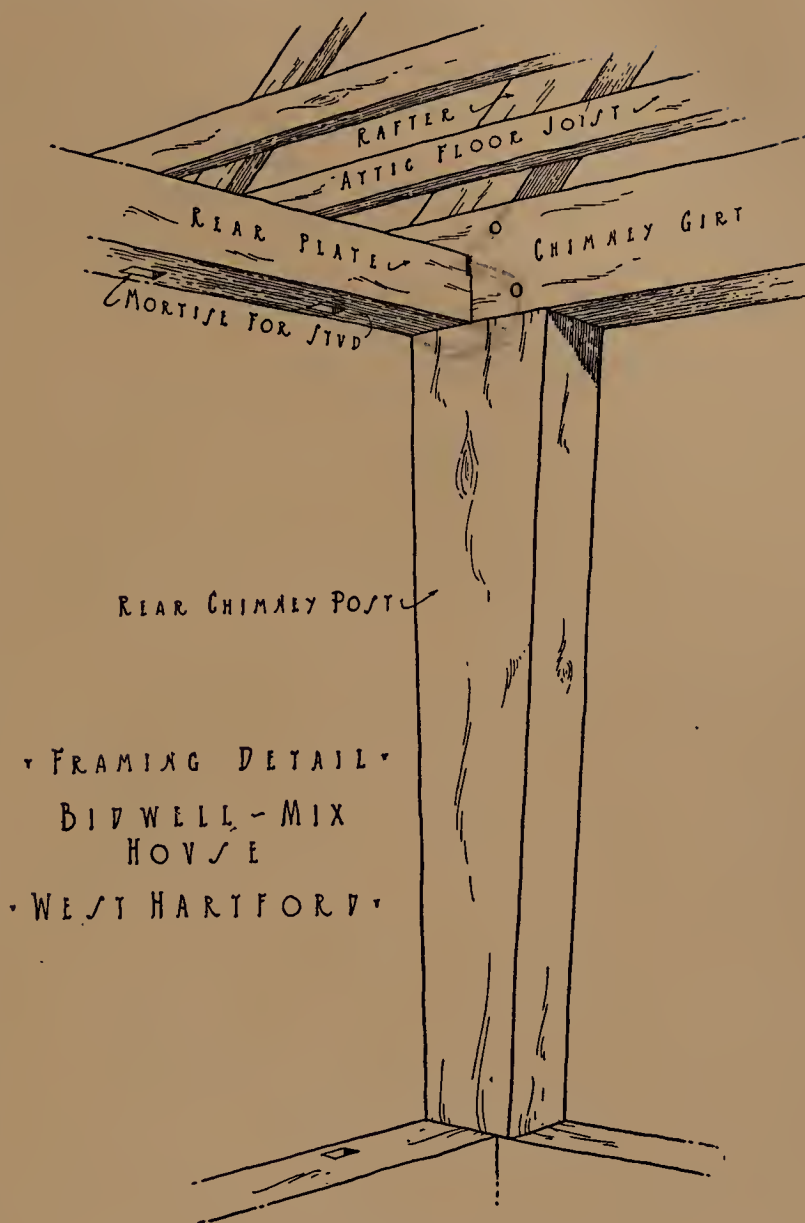
FIGURE 34.

In addition to these girts in the outside walls, two additional timbers, called chimney girts, were framed across the house from front to rear, one on either side of the central chimney. Their ends were secured into the front and rear chimney posts by means of the usual mortise-and-tenon joint. (Figure 34.) It should be noted that the tops of the girts are framed flush, or on the same level with each other, in all cases. The end and chimney girts, because they carry the ends of the summer beams, are always deeper in section than either the front or the rear girts. It is only in extremely rare cases that cambered girts appear, such as the second-story end girts of the Gleason house in Farmington (*circa* 1650-1660). This feature is, of course, purely a survival of half-timber tradition.

smaller common rafters which bear upon it, and which are held in place by pegs. These smaller intermediate rafters are simply rough poles of about four inches' diameter, slightly flattened on the outer side. In both of these houses, the end sets of rafters are above the end girts, and the central pairs above the chimney girts. Rafter feet and girts therefore meet the plate at the same point. (Figure 34.)
